Test report no. PB 5.1/18-418-1

Subject: *FRK sealing collar* -
Testing the tightness in the fitted state at a water pressure of
10 bar

Client: Flexseal GmbH
Hessenring 31
37269 Eschwege
Germany

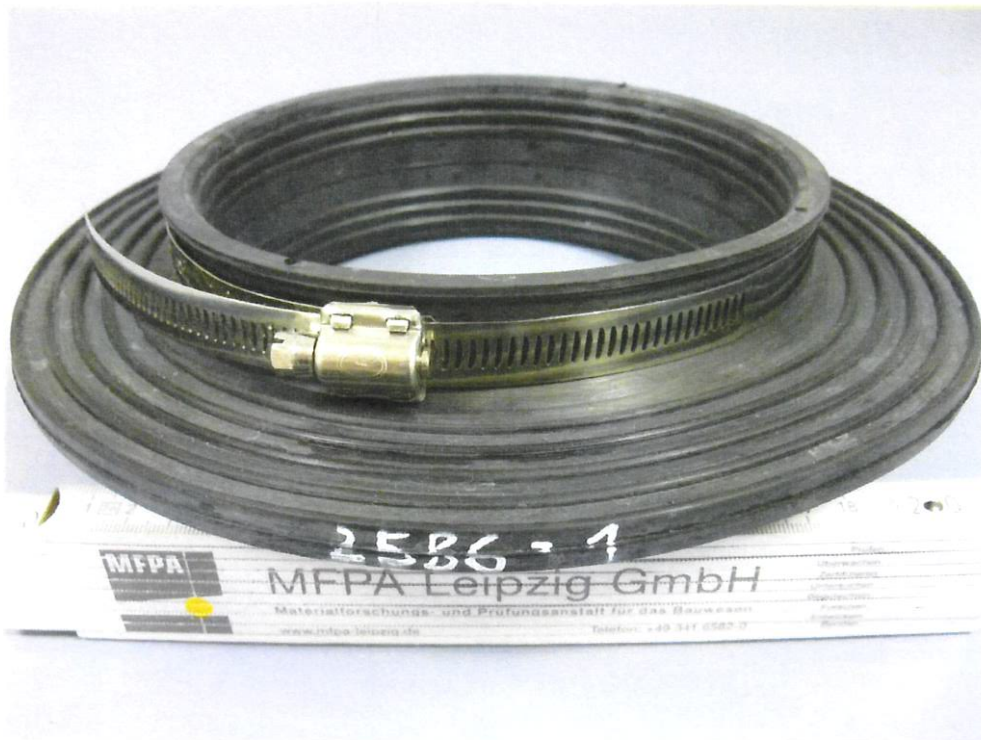
Figure 1 *FRK sealing collar* (here: FRK9416)

The *FRK sealing collar* is a black, cuff-like fitting with profiled discs, Annex 1, Figure 1. According to the client, it is made of EPDM and offered for pipes with an outside diameter of up to 340 mm. The sealing collar is positioned in the middle of the wall or base plate cross section on site above the pipe to be sealed and additionally pressed on with two fastening straps. The profiled discs in the middle of the sealing collar, which is approx. 55 mm wide, aligned perpendicular to the pipe axis are intended to extend the flow path of the water and thus the impermeability of the pipe bushing in concrete or reinforced concrete components with high water penetration resistance. On both sides of the discs, two stainless steel fastening straps, approx. 14 mm wide (material no: 1.4301) secure the position of the sealing collar and ensure the required contact pressure.

The surface of the sealing collar is provided with 2 x 3 annular ribs. The thickness is approx. 9.5 mm in the area of the ribs, outside the ribs approx. 5 mm. The inner diameter of the sealing collar in the area of the ribs is about 150 mm, the outer diameter about 250 mm. The transition between the hollow cylindrical part of the sealing collar that rests against the pipe and the discs is designed as a fillet on both sides. The disc is provided on both sides with five concentrically arranged ribs, approx. 2.5 mm wide. The distance between these ribs is approx. 5.1 mm.

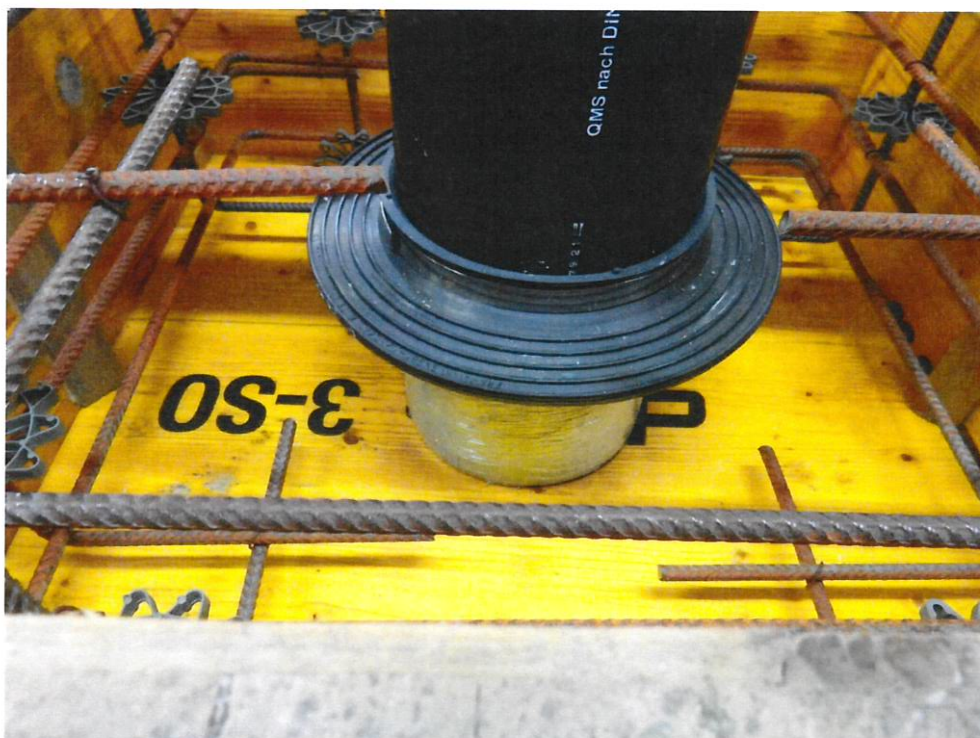
Figure 2 One-sided sheathing of the pipe below the wall collar for later ensuring the water access to the wall collar

For the functional test, a test specimen with dimensions of 0.6 x 0.6 x approx. 0.3 [m] is produced from C30/37 concrete, which has a maximum grain size of 16 mm and a high resistance to water penetration in accordance with DIN 1045-2¹. The installation of the pipe with vertically aligned axis is the most critical installation case due to possible sacking below the disc. For the test, the tube is wrapped with filter paper and a membrane on the closed side, Annex 1, Figure 2.

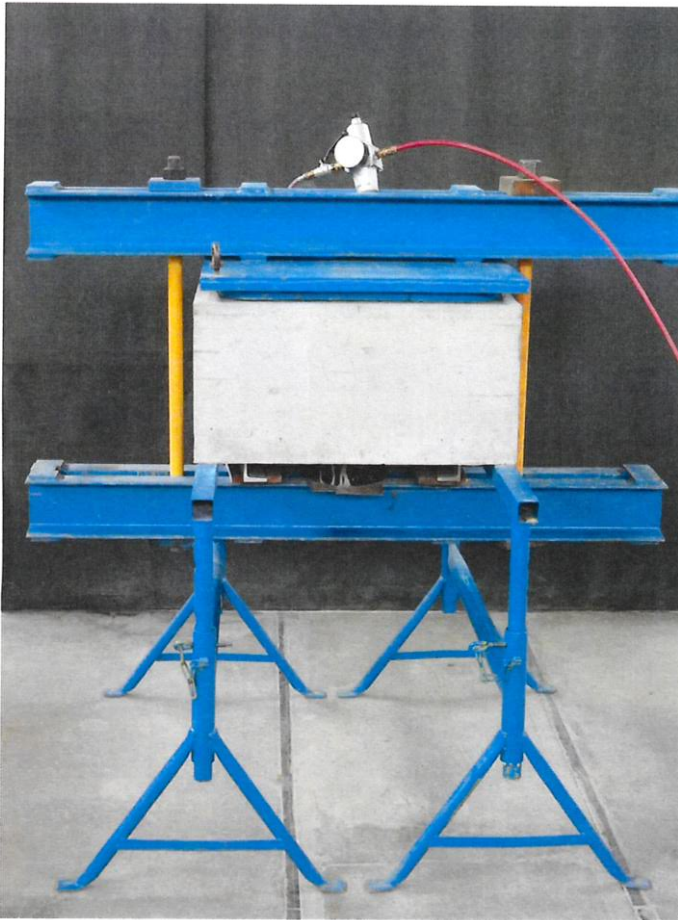
Figure 3
Test specimen during impermeability test
at water pressure

The test begins four weeks after preparation of the test body. A pressure chamber is fixed over the closed pipe end and sealed so that the installed component and the surrounding part of the concrete surface are located within the chamber. The chamber is filled with water through an opening and pressurised. The water pressure acts on the joint between concrete and pipe during the test. A four-week exposure at a maximum water pressure of 10 bar is envisaged. To this end, in the first week the water pressure is increased daily by 1 bar to 5 bar. In the second week the water pressure is increased daily by 1 bar to 10 bar and this pressure is maintained for a period of 28 days, Annex 1, Figure 3.

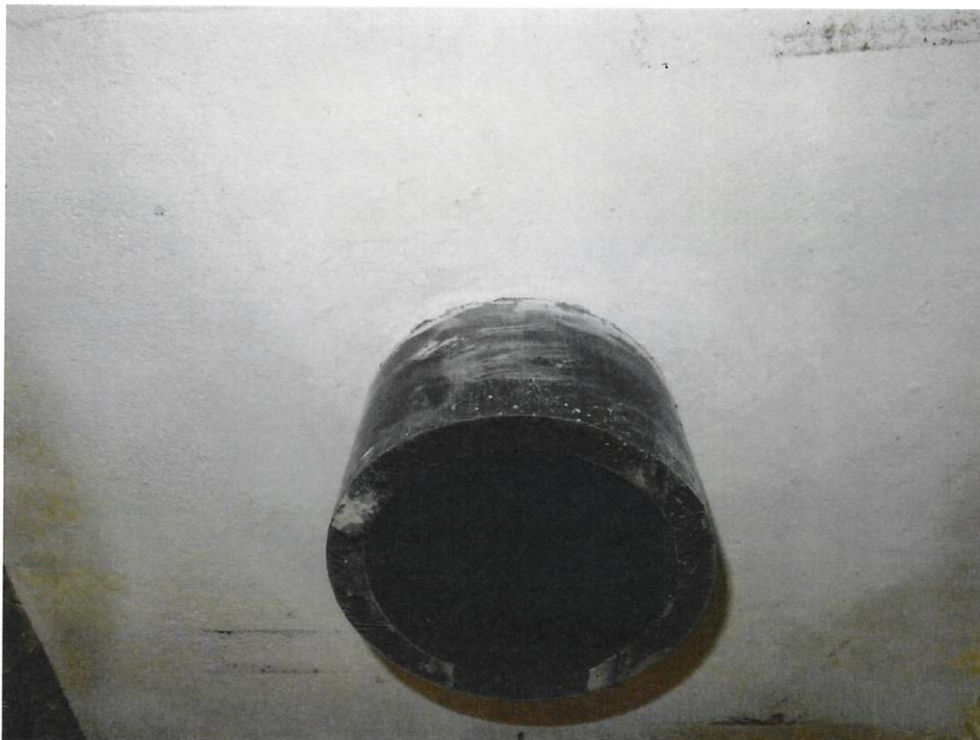
Figure 4 Bottom of the test specimen immediately after the demounting
of the traverses

During the four-week exposure to pressurised water at 10 bar, the joint between the *FRK sealing collar* sealed pipe and the surrounding concrete was watertight, Annex 1, Figure 4. The splitting of the test specimen after disassembly of the test equipment showed a moisture spread of the concrete on the side of the sealing collar exposed to pressurised water and dry concrete on the side facing away from the water, Annex 1, Figure 5 and Figure 6.

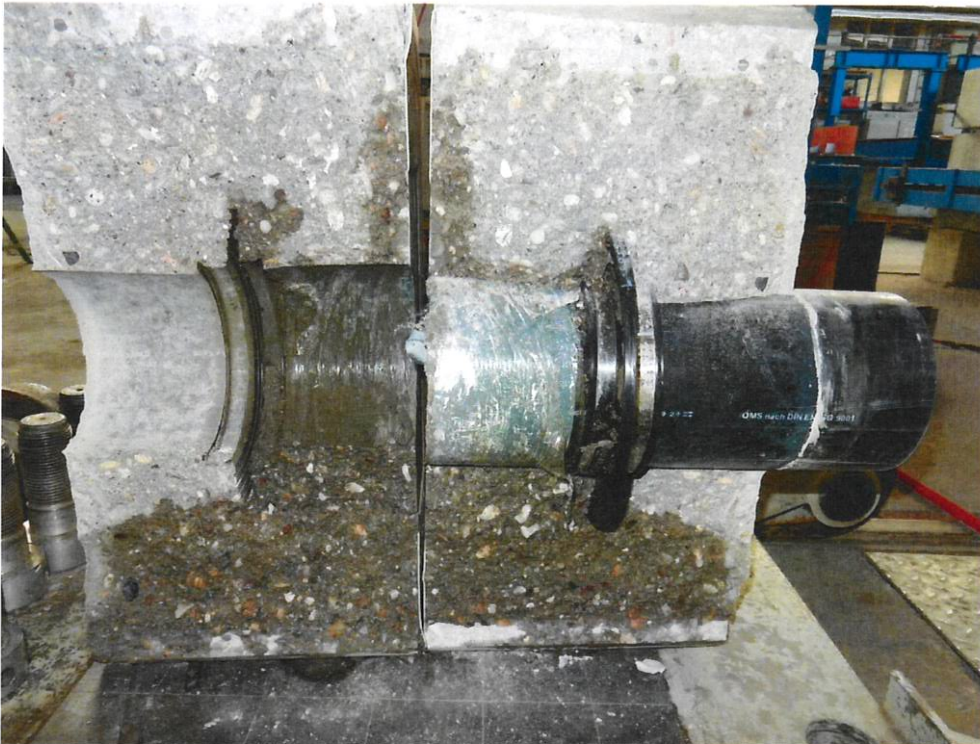
Figure 5 Split test specimen; inside: Water side; outside: dry side sealed by the sealing collar; extended spread at the bottom due to run-off residual water during splitting

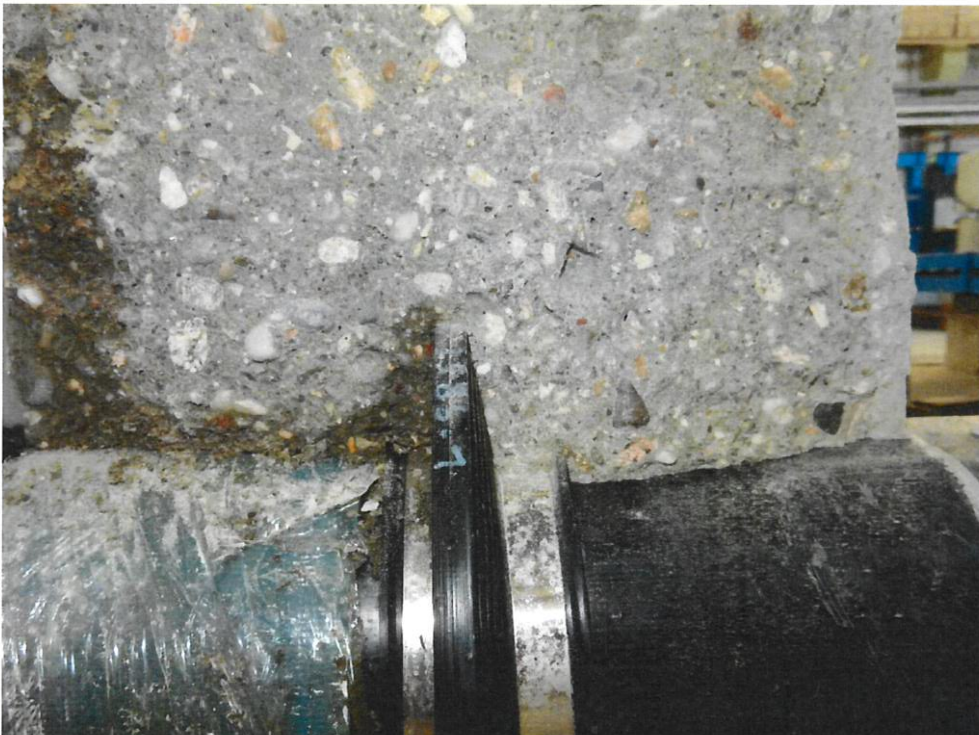
Figure 6 ditto, detail; water side left
